EV - Intelligent Report

Vehicle: TESLA Model 3

Reason for this report: Evaluation, solution and budget for repair of TESLA Model 3 - 2020

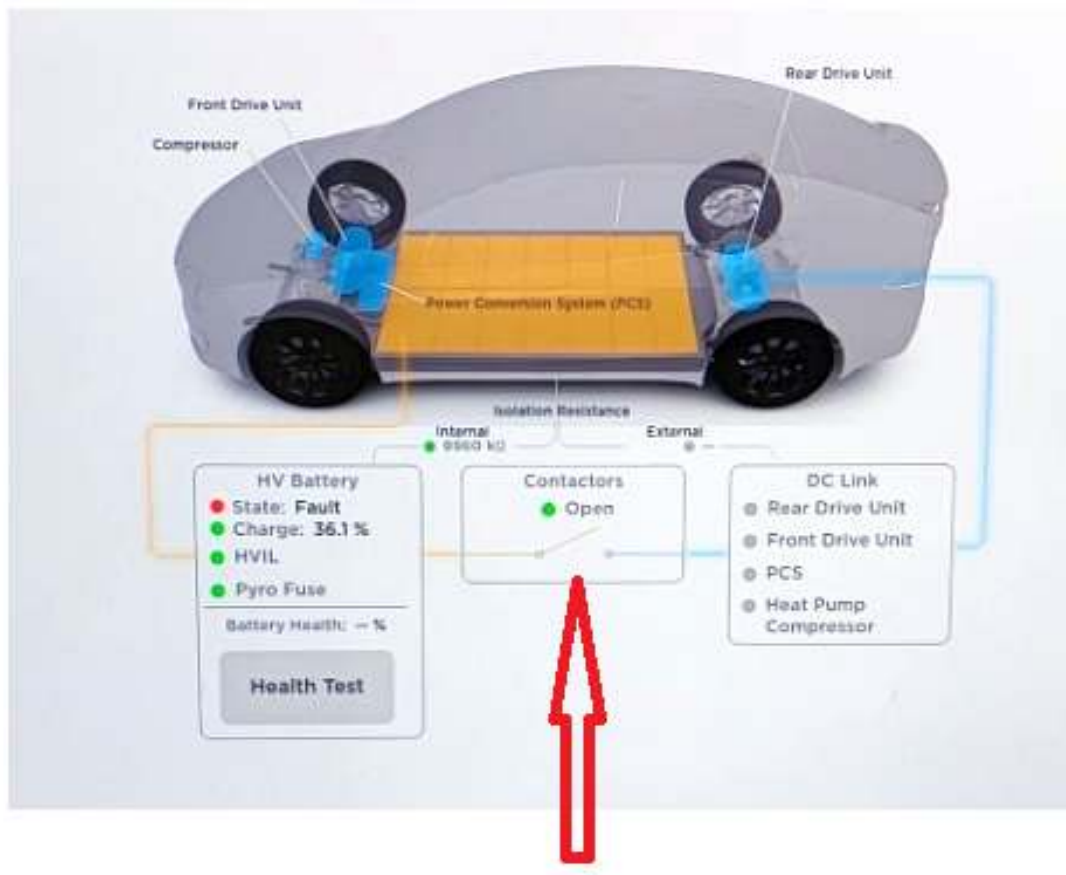
According to the measurements made, the insulation leak occurs inside the rear drive unit.

In our lab we can try to repair the insulation loss in the Drive Unit, either in the motor or in the inverter.

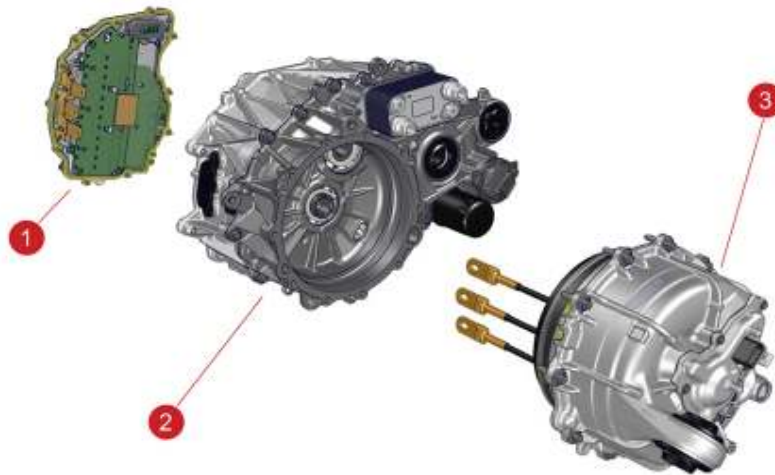
1. Drive Inverter
2. Gearbox
3. Motor

The loss of insulation can occur in the motor or inverter windings.
