Last Modified: 10-24-2011	6.4 C	From: 200808
Model Year: 2009	Model: Highlander HV	Doc ID: RM000000Y7K00YX
Title: P310 HYBRID VEHICLE CONTROL: HYBRID CONTROL SYSTEM: P0A78-286: Drive Motor "A" Inverter Performance (2009 Highlander HV)

DTC	P0A78-286	Drive Motor "A" Inverter Performance
------------	------------------	---

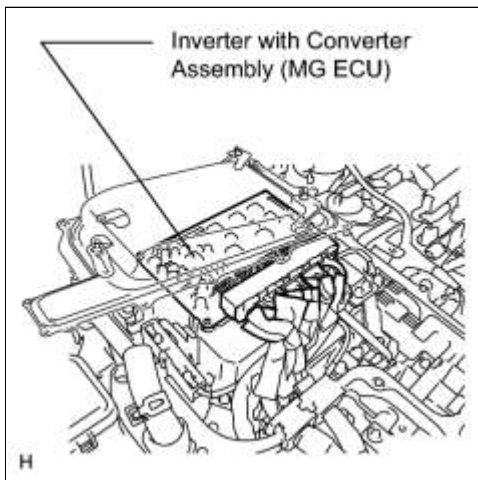
(d) Check the connections of the MG ECU connectors.

The connectors are connected securely and there are no contact problems.

NG ▶ CONNECT SECURELY

OK ▶ REPLACE INVERTER WITH CONVERTER ASSEMBLY
